A Naval Safety Center Publication

approach

JULY 1972 THE NAVAL AVIATION SAFETY REVIEW

Fire in Flight

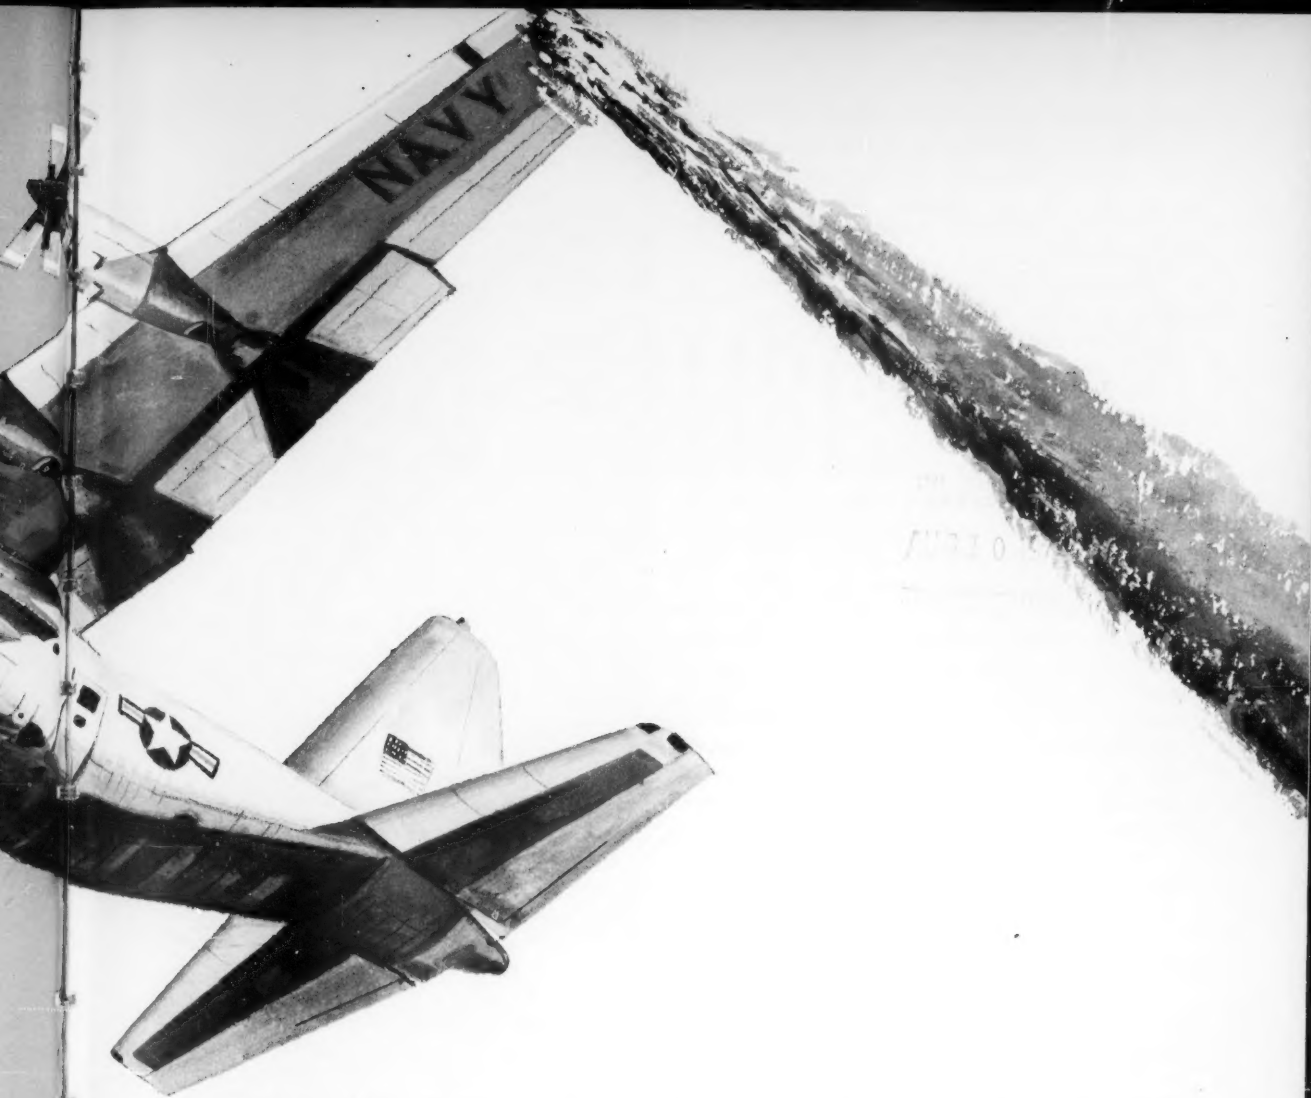
The 2P, now in the left seat, exclaimed over the ICS, "That felt like a bird strike!" The AC looked out the right window and noticed a reflection of flames on the No. 4 engine nacelle. He thought the No. 3 engine was on fire. He turned to execute engine fire shutdown procedures but noticed there were no fire warning indications for *any* engine.

As he looked again at the No. 4 engine, the 2P notified him that the left wingtip was on fire. The flight engineer isolated the port wing bleed air system. The AC

The most probable cause of the fire was a short in the cannon plug for the No. 1 fuel quantity gage. This allowed 115 volts a.c. current to be routed to the internal fuel tank wiring. An arc or spark apparently jumped from the wiring to ground at some point in the tank.

Such an arc or spark would not cause an explosion or fire if submerged in fuel. However, it is suspected that sufficient fuel had been burned to leave space above the fuel which contained a suitable fuel-air mixture for ignition by the arc. (Refer to NAVSAFECEN Flight Advisory 5-72, reprinted in the accompanying box.)

Investigation revealed an uncorrected aircraft discrepancy of long standing, i.e., a malfunctioning fuel tank indicator which was first griped more than 2 months before the accident. This discrepancy was not considered cause for downing the aircraft. The yellow sheet discrepancy read, "No. 1 main fuel tank reads off scale at all times." Corrective action read, "Repaired coax cable, checks good," and "Repaired cannon plug, checked good."

For NAVAIRSYSCOMHQ: Recommend that maintenance procedures for correcting fuel quantity indication discrepancies be revised to provide that any fuel quantity indicator with a known discrepancy be disabled before release for flight or before ground maintenance by pulling and tagging the indicator circuit breaker where applicable. Further recommend prohibit inflight troubleshooting of fuel quantity indicating system which would involve connecting or disconnecting cannon plugs.

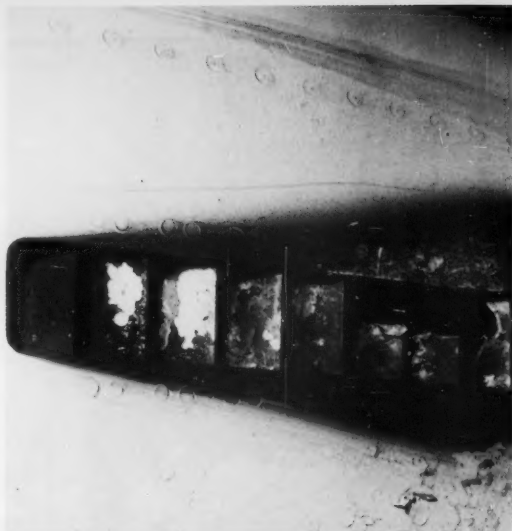
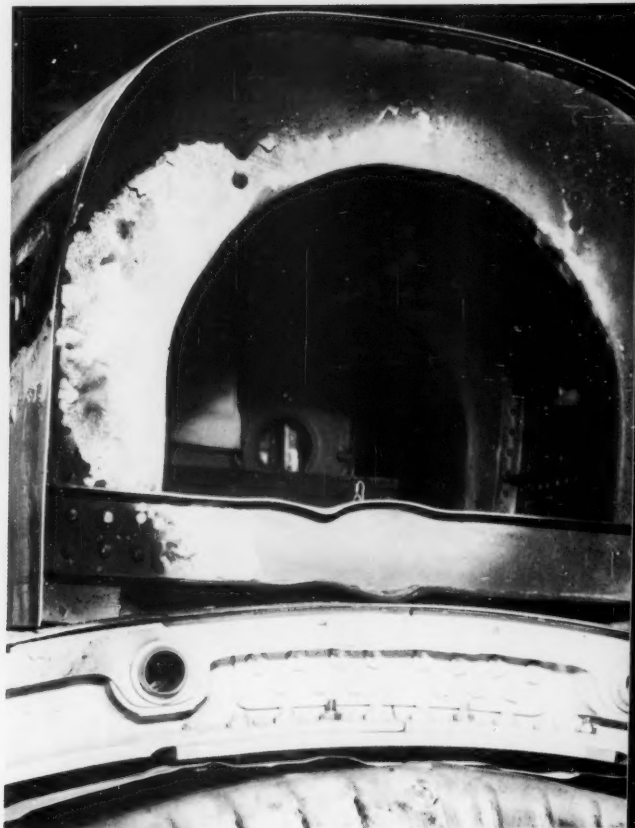
Photos show fire damage in the hump area just aft of the fuel filler cap.

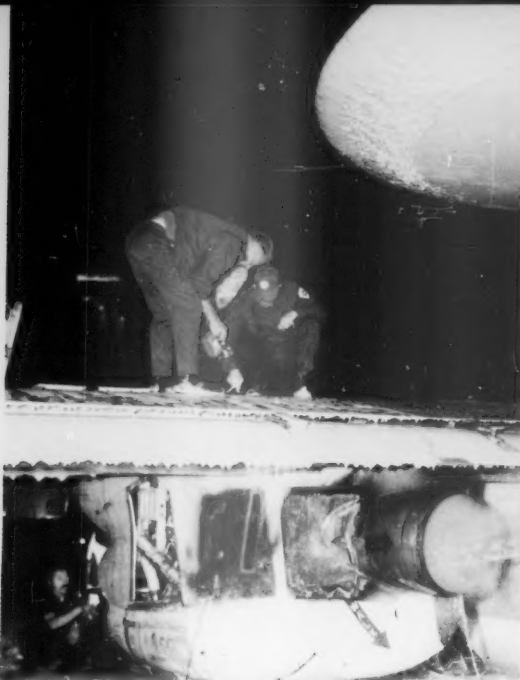
Fire did extensive damage to the port engine nacelle.

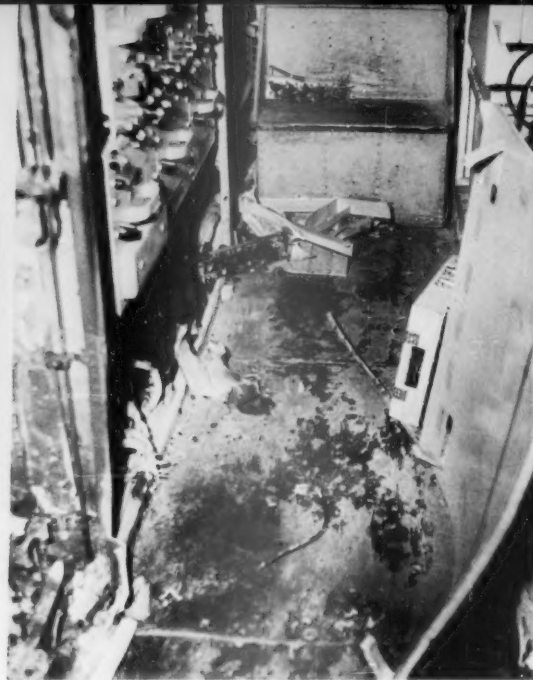
Interior forward equipment compartment damage.

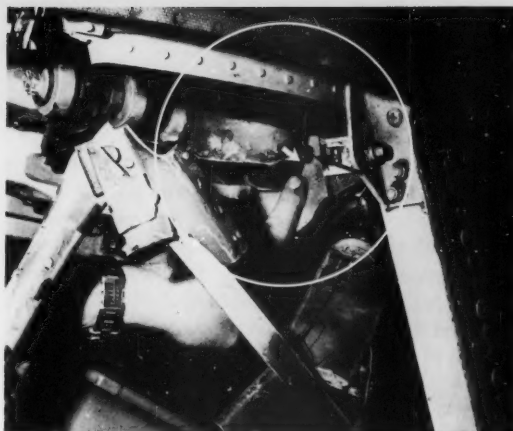
Finger points to partially withdrawn lower pitch rod bearing bolt.

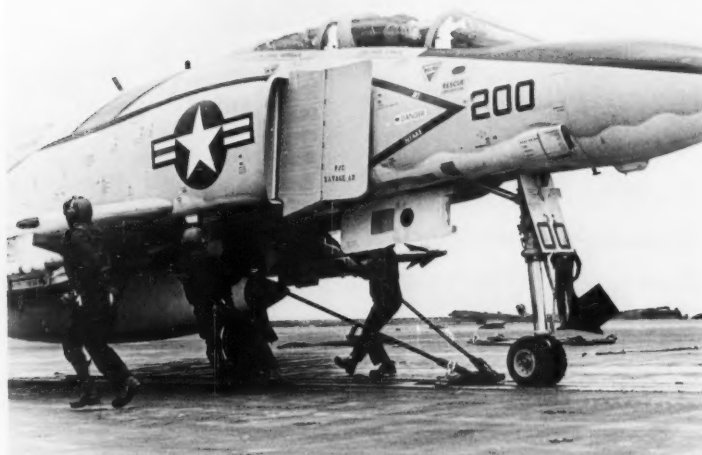
Arrow points to the tire in question.
